# VEHICLE INSPECTION REPORT

**PF20ACO**

## Mercedes-Benz Sprinter 314 CDI

### Inspection

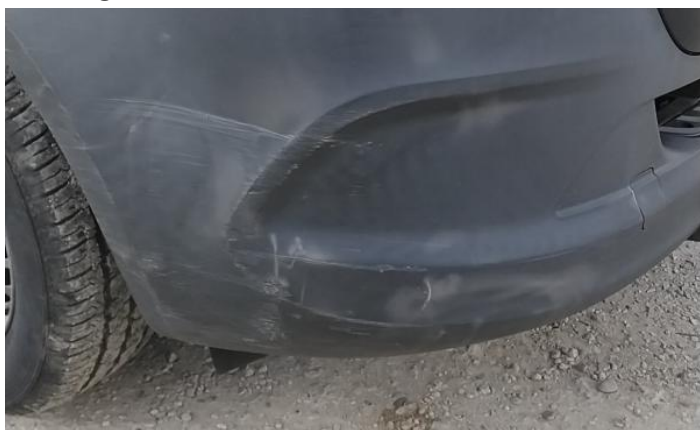
1: Bumper Front Moulding  
Scuffed (Unpainted)  
Over 100mm

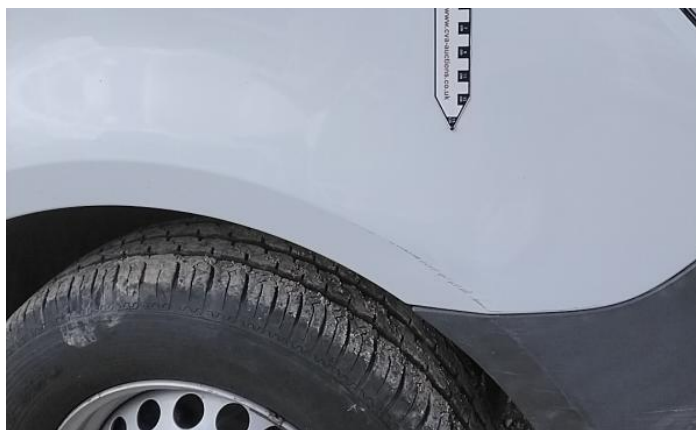
2: Wing osf  
Scratched  
Over 25mm Thru Paint

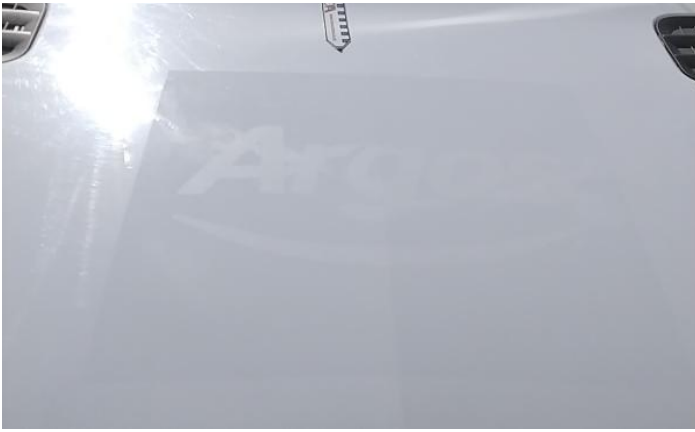
3: Bonnet  
Chipped  
Multiple Chips

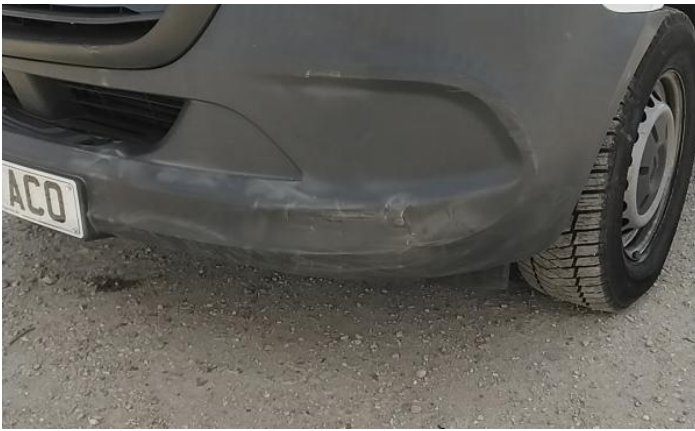
5: Bumper Front Moulding  
Scuffed (Unpainted)  
Over 100mm

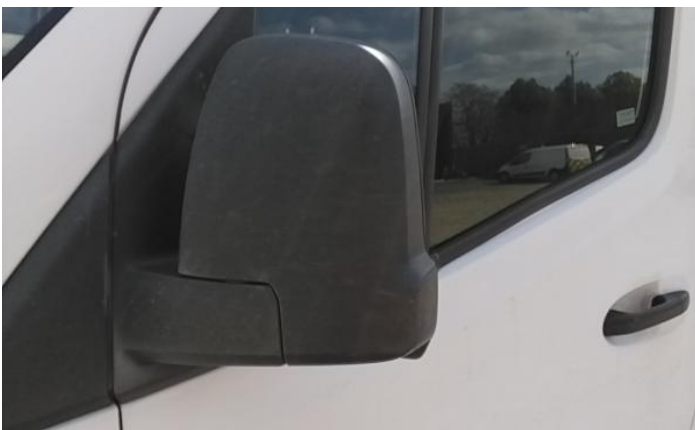
7: Door Mirror Assy nsf  
Scuffed (Unpainted)  
Over 100mm

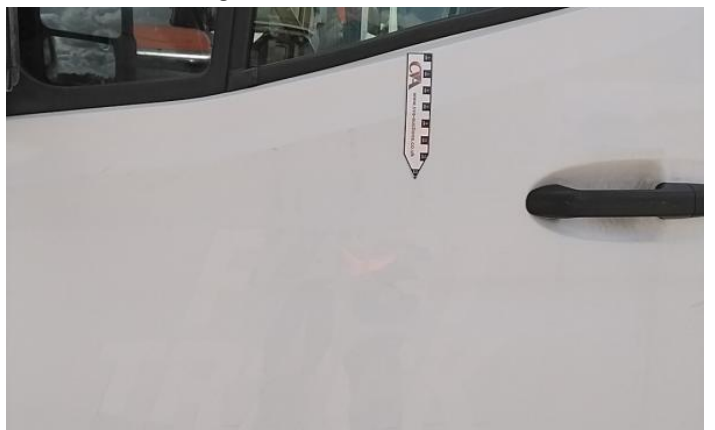
8: Door nsf  
Scratched  
Over 25mm Not Thru Paint

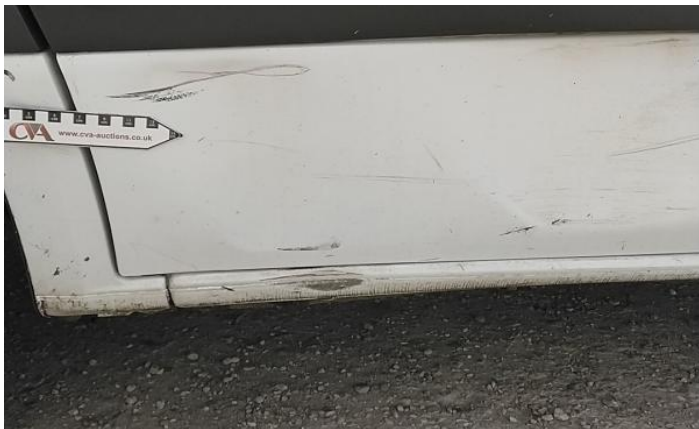
9: Door nsf  
Dented  
Over 30mm

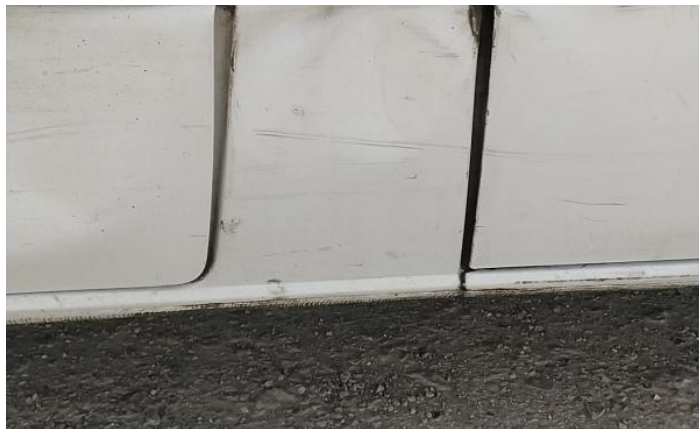
10: B Post ns  
Dented  
With Paint Damage

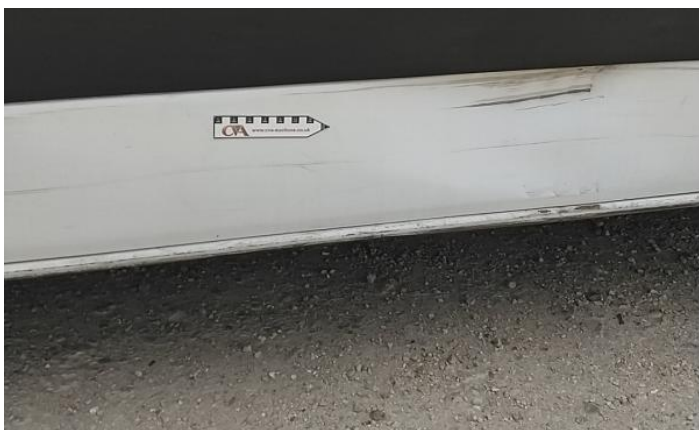
11: Door nsr  
Dented  
With Paint Damage

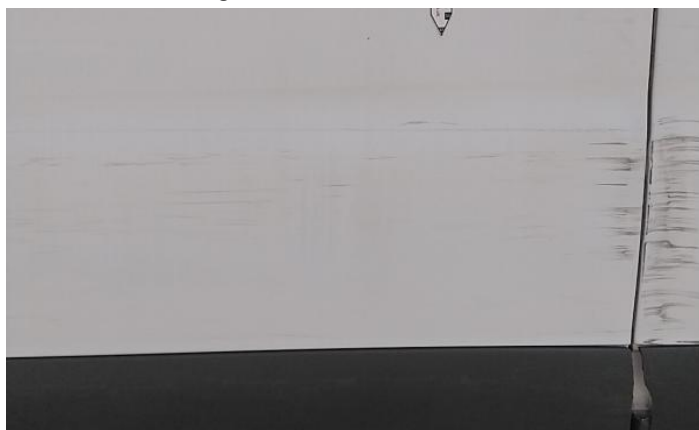
12: Door nsr  
Dented  
Over 30mm

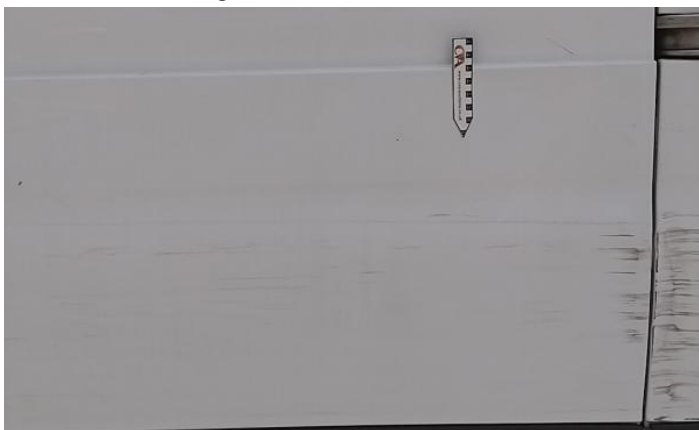
13: Door nsr  
Scratched  
Over 25mm Thru Paint

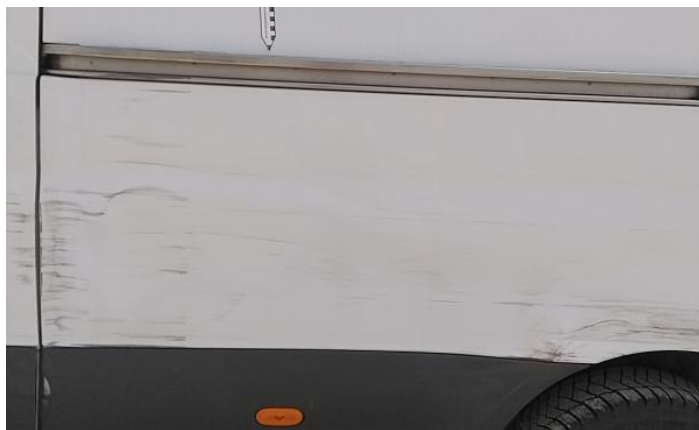
14: Qtr Panel nsr  
Dented  
With Paint Damage

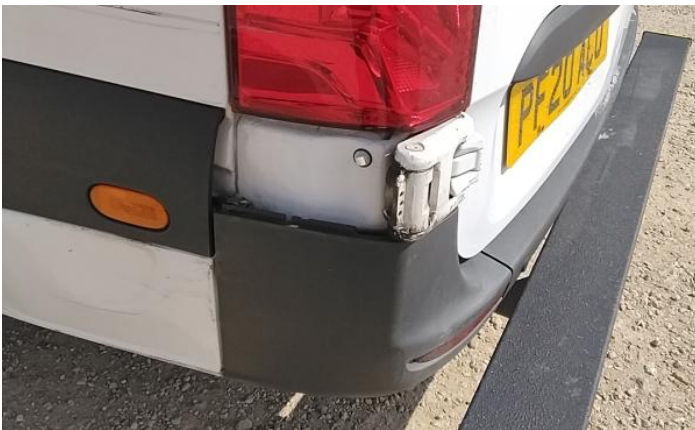
19: Bumper Rear Moulding  
Missing  
Replace

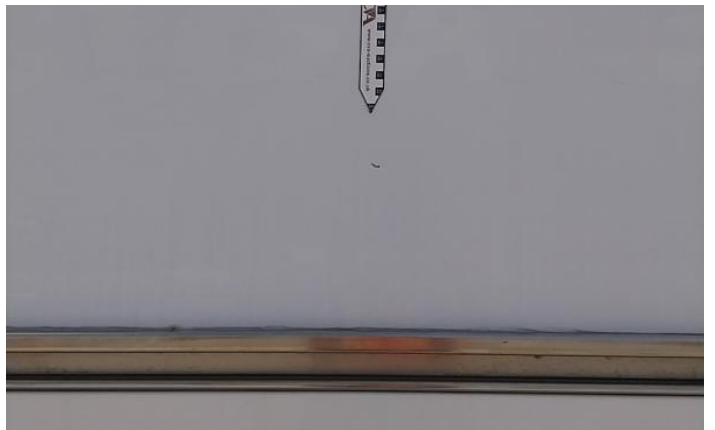
20: Qtr Panel nsr  
Dented  
With Paint Damage

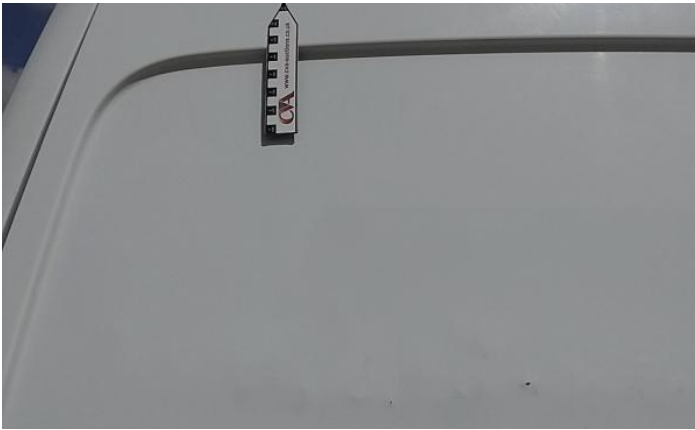
21: Door nsr  
Dented  
Over 30mm

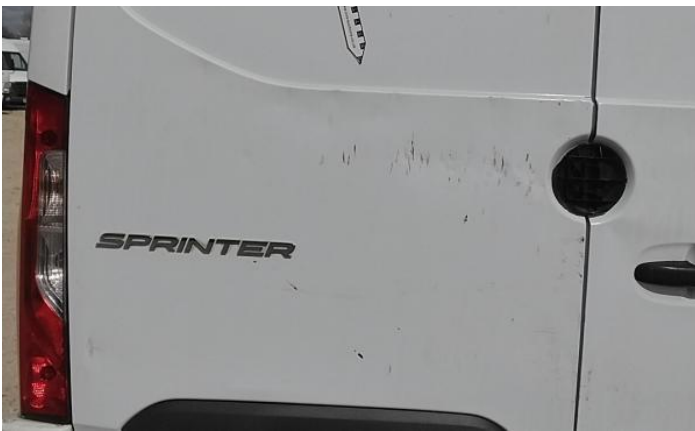
23: Door nsr  
Dented  
With Paint Damage

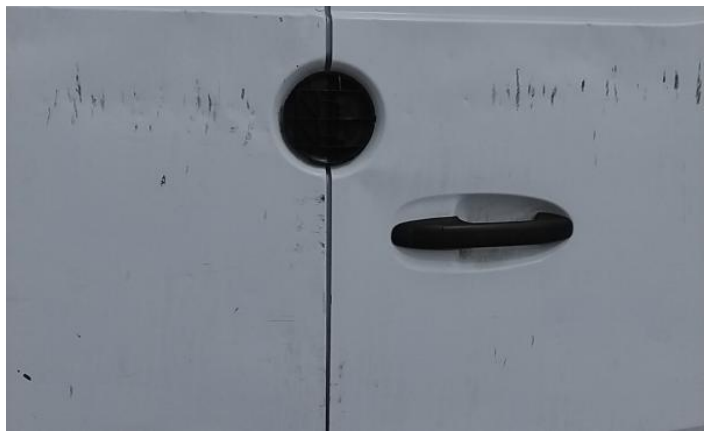
24: Badgedecal Rear  
Missing  
Replace

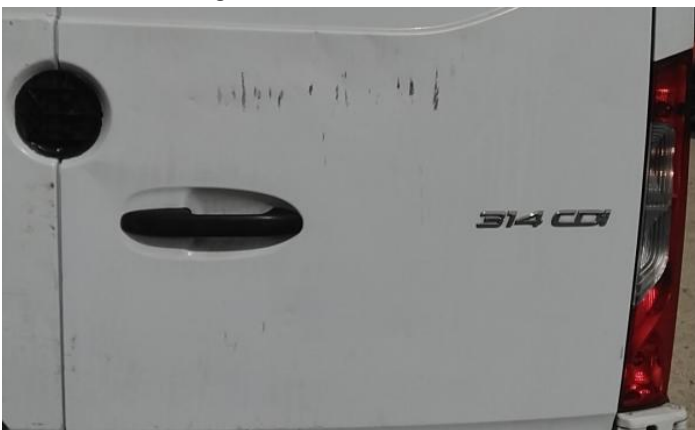
25: Door osr  
Dented  
With Paint Damage

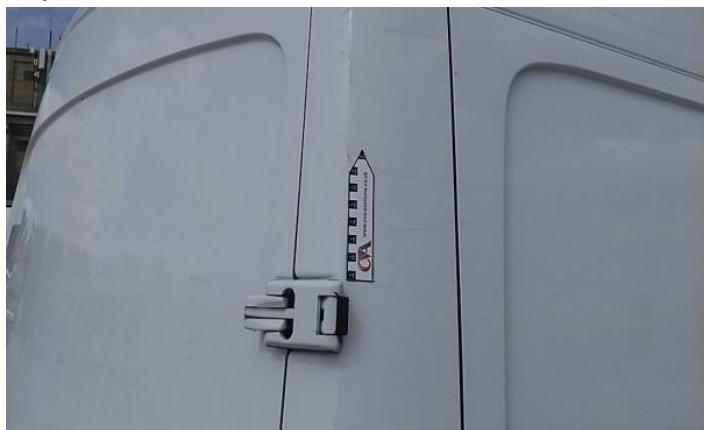
26: Qtr Panel osr  
Dented  
With Paint Damage

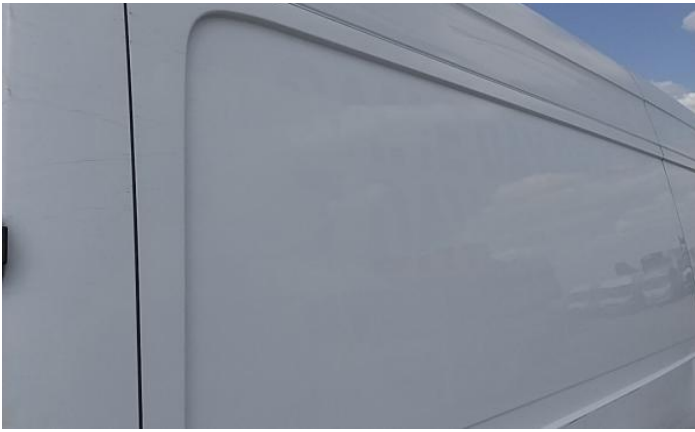
27: Qtr Panel osr  
 Scratched  
 Over 25mm Not Thru Paint

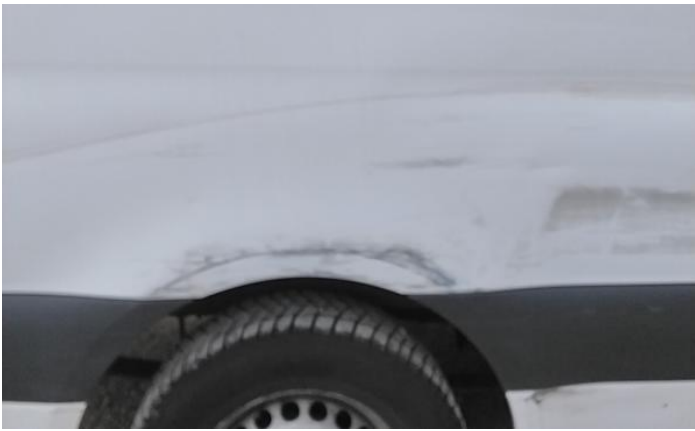
29: Qtr Panel osr  
 Scratched  
 Over 25mm Thru Paint

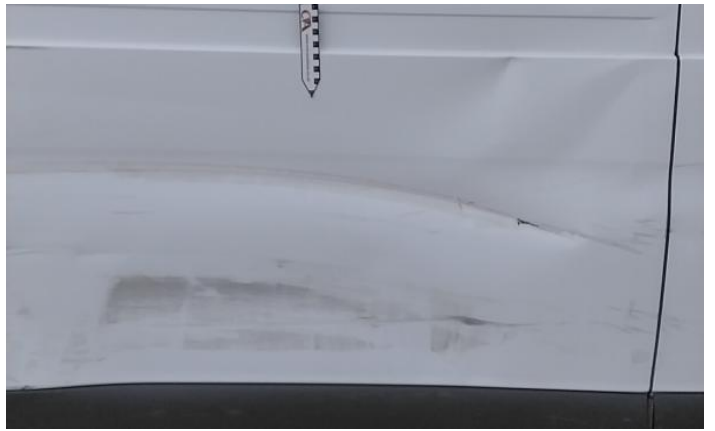
30: Qtr Panel osr  
 Dented  
 With Paint Damage

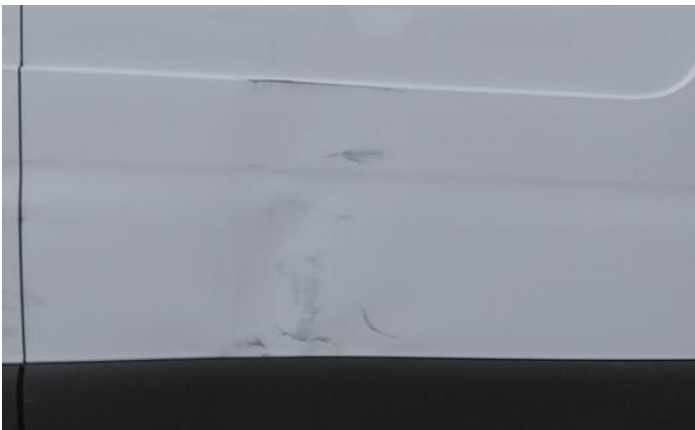
31: Qtr Panel osr  
 Dented  
 With Paint Damage

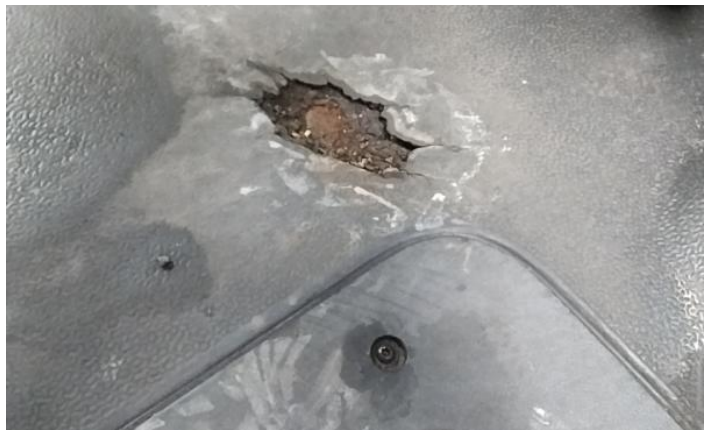
32: Carpets Front  
 Holed  
 Over 3mm

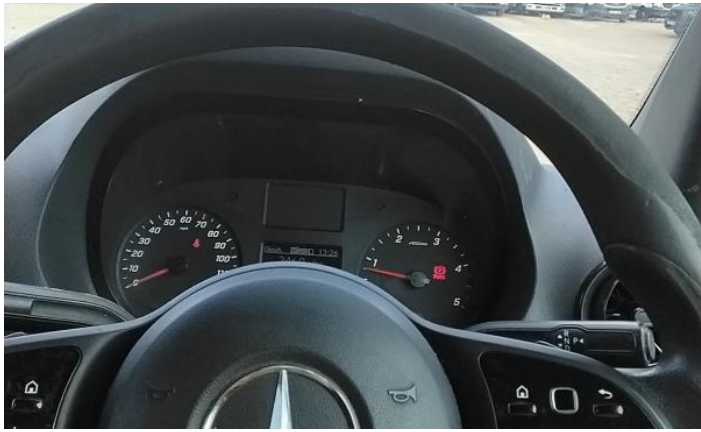
33: Steering Wheel  
 Damaged  
 Replace
