# VEHICLE INSPECTION REPORT

**BX59DGY**

## Daf LF 45.160

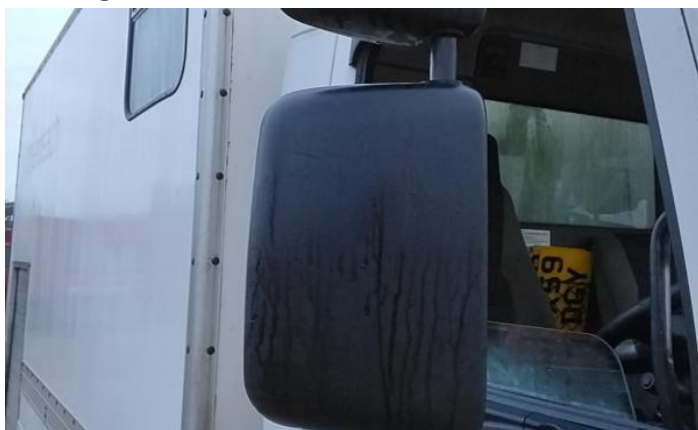
1: Door Mirror Assy osf  
Scuffed (Unpainted)  
Over 100mm

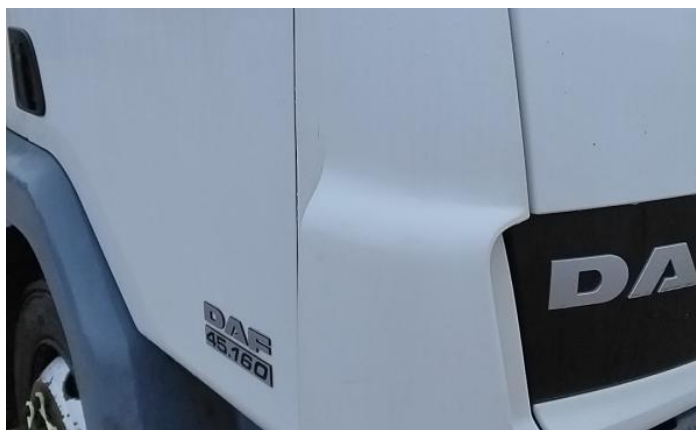
2: Wing osf  
Scratched  
Over 25mm Not Thru Paint

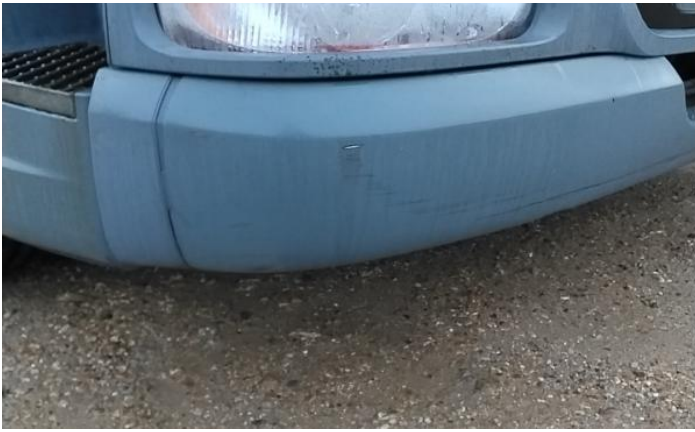
3: Bumper Front Moulding  
Scuffed (Unpainted)  
Over 100mm

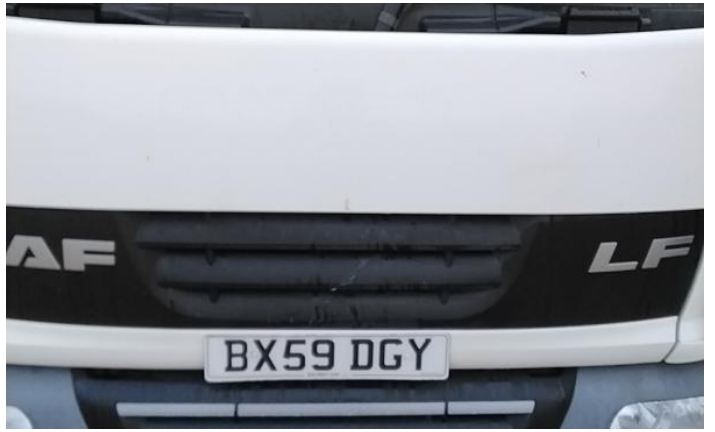
4: Bonnet  
Chipped  
Multiple Chips

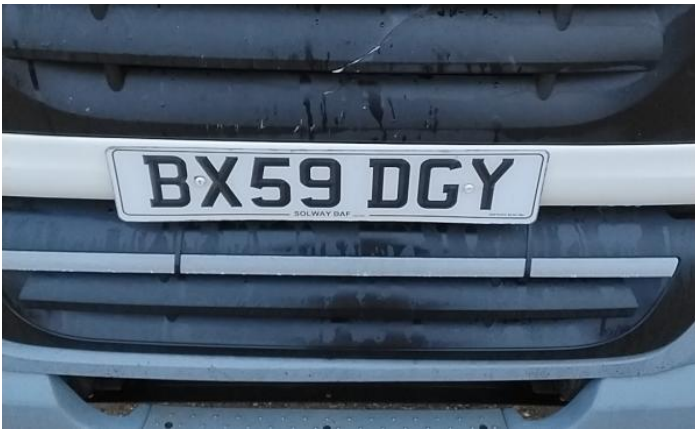
5: Grille Front  
Broken  
Replace

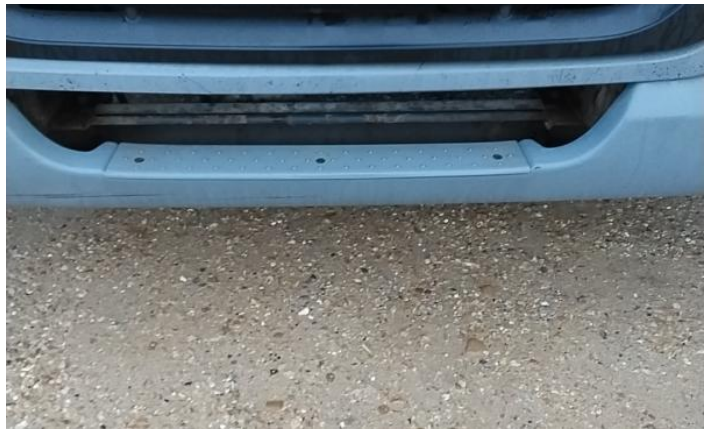
6: Grille Front  
Broken  
Replace

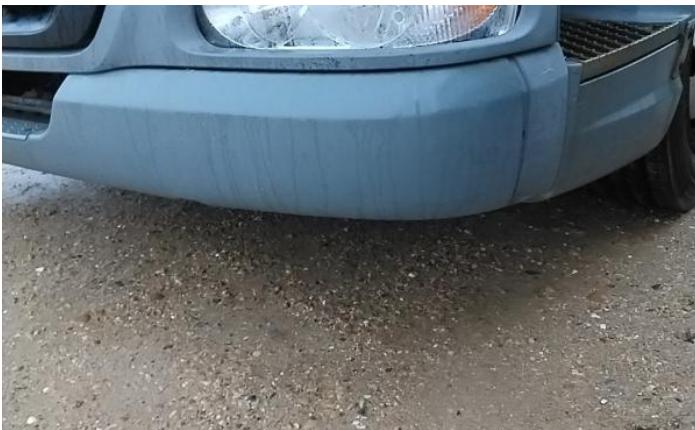
7: Bumper Front Moulding  
Scuffed (Unpainted)  
Over 100mm

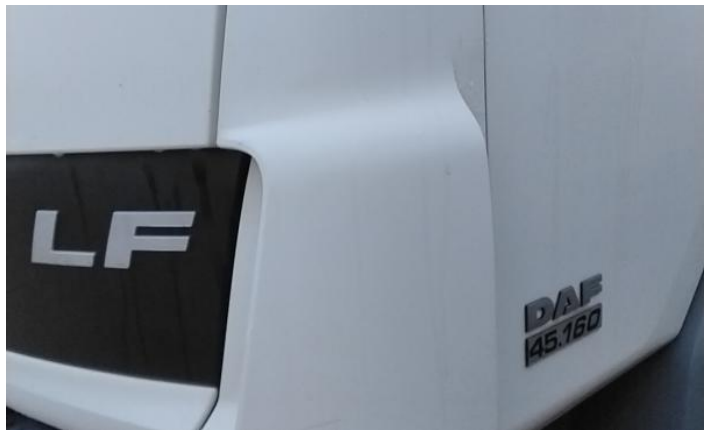
8: Wing nsf  
Scratched  
Over 25mm Thru Paint

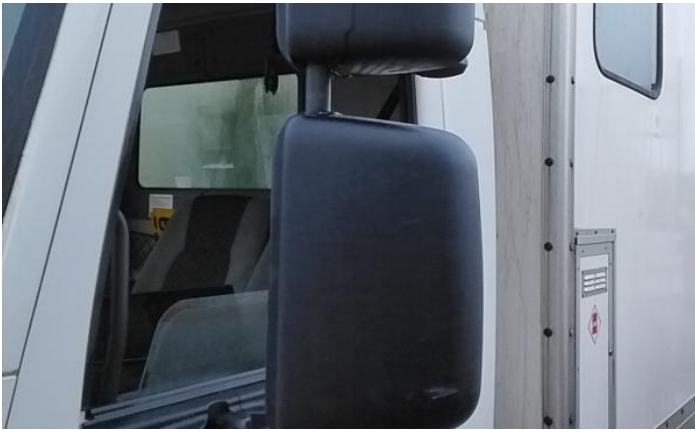
9: Door Mirror Assy nsf  
Scuffed (Unpainted)  
Over 100mm

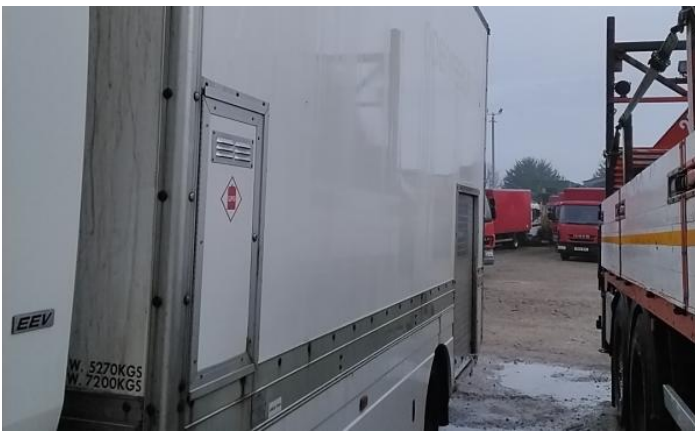
11: Panel Rear  
Scratched  
Over 25mm Thru Paint

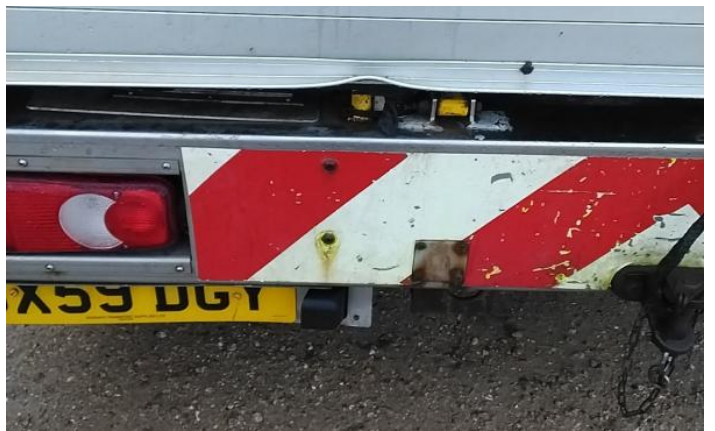
12: Door nsr  
Dented  
Over 30mm

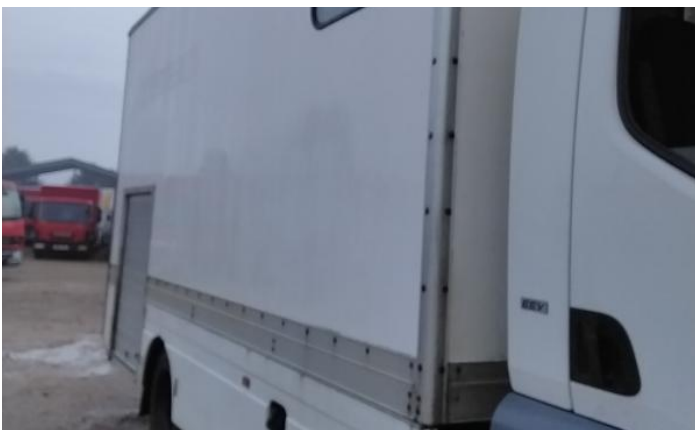
13: Panel Rear  
Scratched  
Over 25mm Thru Paint

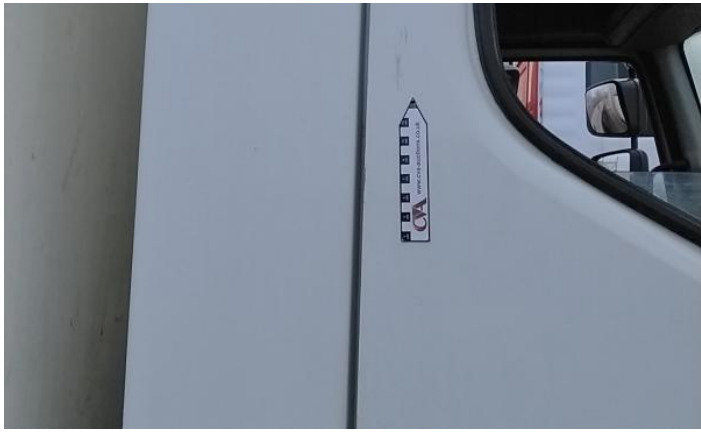
15: Door osf  
 Scratched  
 Over 25mm Not Thru Paint
